## REMOVAL ACTION REPORT

# Anderson-Calhoun Mine/Mill Site Leadpoint, Washington

March 2003

**HERRERA**  
ENVIRONMENTAL  
CONSULTANTS

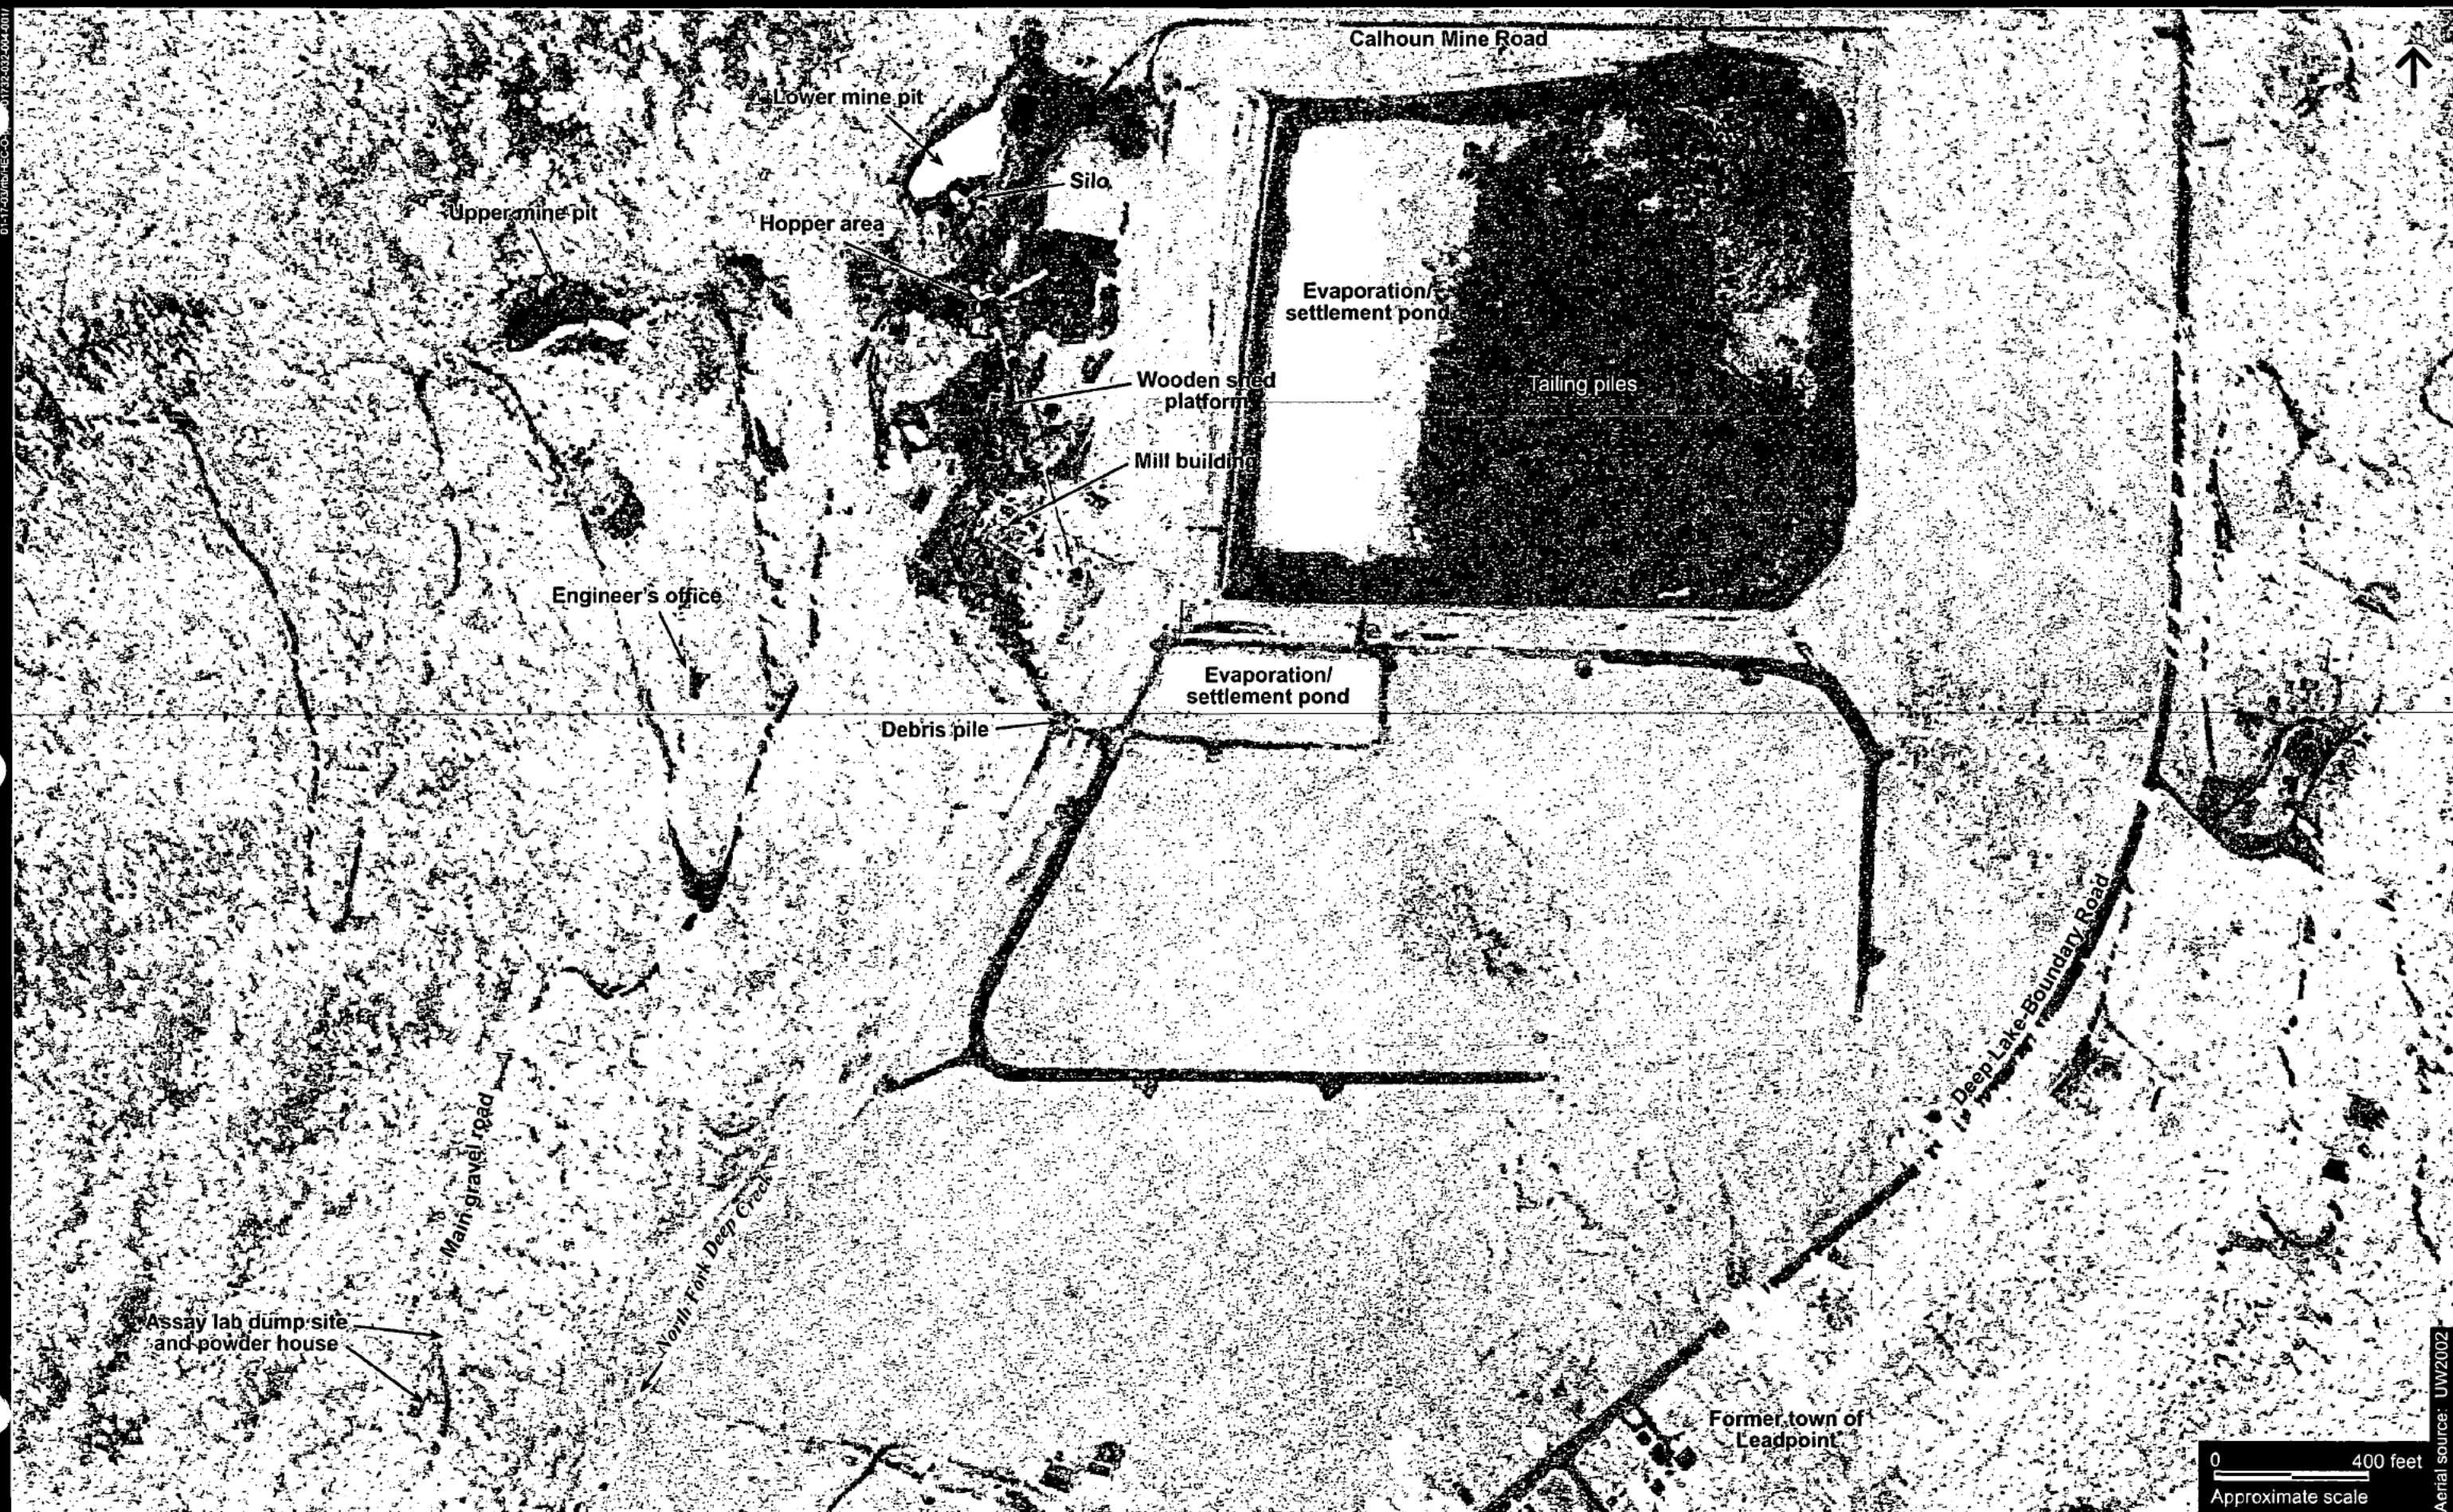
Figure 3. 1995 aerial photograph of the Anderson-Calhoun Mine/Mill site in Leadpoint, Washington.

Mine and mill operations at the Anderson-Calhoun Mine/Mill site were located south of the water-filled lower mine pit at the west end of the main road access (Calhoun Mine Road), which intersects Deep Lake-Boundary Road at the northeast corner of the property (Figure 3). Evaporation and settlement ponds contained by berms constructed of waste rock material and tailing piles left over from the mill process are located on the valley floor east of the site and south of Calhoun Mine Road. Most of the operational structures within the site were demolished, with building concrete foundation pads remaining in-place for the electrical room, the dry room (mine workers locker room), two equipment warehouses, an office and assay lab, the engineer's office, the maintenance and repair shop, the wooden storage shed, the bag house, and the truck scale (Figure 4; McNinch 2002). The remaining intact structures included the mill building, the hopper (upper and lower) and primary crusher building, the secondary crusher building, the electrical substation, the first aid room, remnants of a conveyor belt system, the portal and shaft, the silo, and the powder house (Figure 4; McNinch 2002). Other site features include an estimated 10,000-gallon underground storage tank and drum storage rack, both located north of the mill building along the main road to the site.

The mill building was the largest structure on-site, 50 feet wide, 75 feet long, and 40 feet high (E&E 2002). The building was located west and adjacent to the base of a hill approximately 80 feet high, with a portal and shaft hopper connected to the mill by a conveyor belt. The mill consisted of several crushers, ball mills, flotation tanks, and filtering discs.

The assay lab dump site was discovered during a site reconnaissance of the upper mine pit area on October 30, 2002. The dump site was located on the east side of the main gravel road approximately 0.5 mile southwest and uphill from the main mine/mill site (Figure 3). The former powder house, where explosives used for mining were kept, was located across the road. The powder house was found empty. A barbed wire fence oriented east/west and across the road approximately 240 yards south of the dump site appeared to represent the mine property boundary.

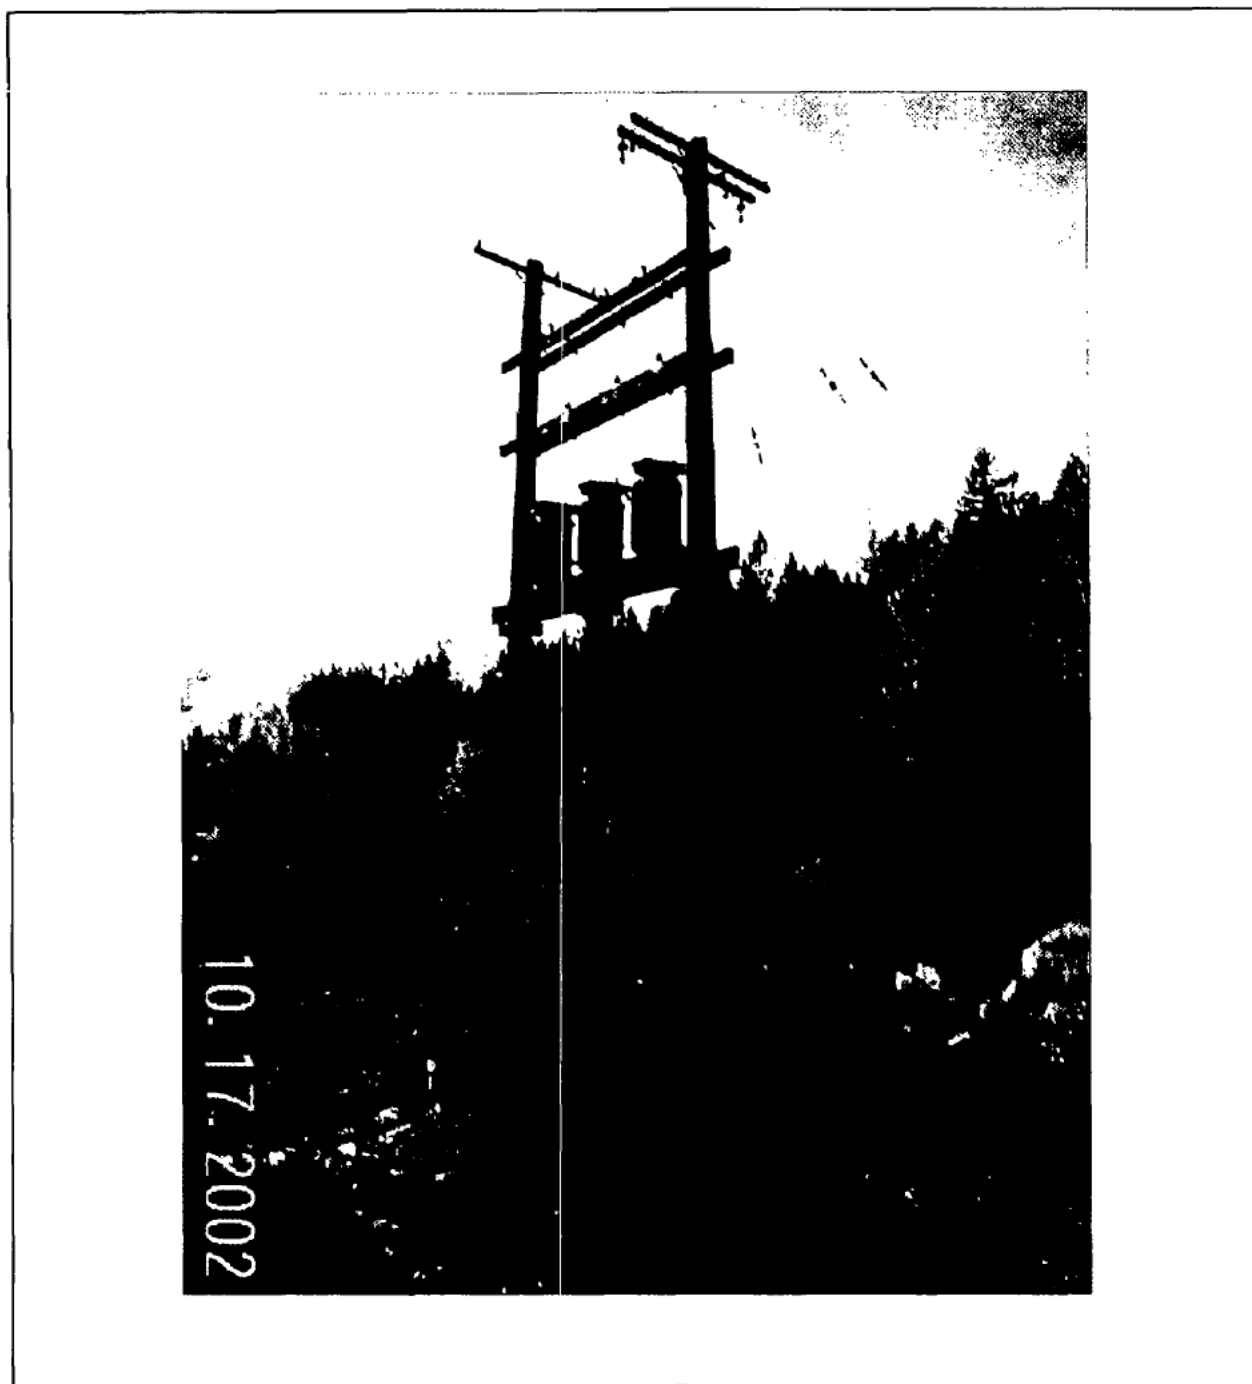
**Figure 9.** View of three transformers on a pole-mounted platform (later designated as T19, T20, and T21), view from the upper hopper area looking to the southwest, Anderson-Calhoun Mine/Mill site in Leadpoint, Washington.

Three large platform-mounted transformers on power poles were observed on top of the hill next to the upper hopper area north of the mill building (T19, T20, and T21). Each transformer had a total oil capacity of 44 gallons (Figure 9).

- An accidental spill occurred late in the day during ERRS' attempt to remove an oil-filled transformer (T21) from its pole-mounted platform, which caused the crane to topple over and drop the transformer onto the slope below. Removal work was halted to upright the crane and assess the condition of T21 (refer to Transformer T21 Spill Incident section of this report).

- START observed and documented ERRS removal of transformer T21 from the slope using a track hoe. ERRS attempted to remove oil-filled transformer T20 from the same pole-mounted platform as T21; however, oil released from T20 onto the slope below as it was swung over to the staging area (upper hopper area). The OSC and START halted work and revised the work plan to remove pole-mounted transformers by draining oil into drums prior to dismounting them from power poles.

- ERRS drained oil from pole-mounted transformers T19, T26, T27, and T28 into drums, and START collected confirmation oil samples.
- START observed and documented ERRS removal of oil-stained soil from the hill slope where oil released from transformers T20 and T21. A track hoe and hand shovel were used.
